**SOLID AND HAZARDOUS WASTE MANAGEMENT BRANCH
COMPLIANCE ASSESSMENT**

TO: Karen G. J'Anthony, Environmental Program Manager I, SHWMB *KGJA 7/31/08*
FROM: Melissa A. Ferree, Engineer II, SHWMB *MAF 7/29/08*
DATE: July 28, 2008
SUBJECT: Compliance Assessment at Procino Plating
REFERENCE: DED982362543, FILE CODE: 21

PURPOSE OF ASSESSMENT: Follow-up Inspection (FUI)

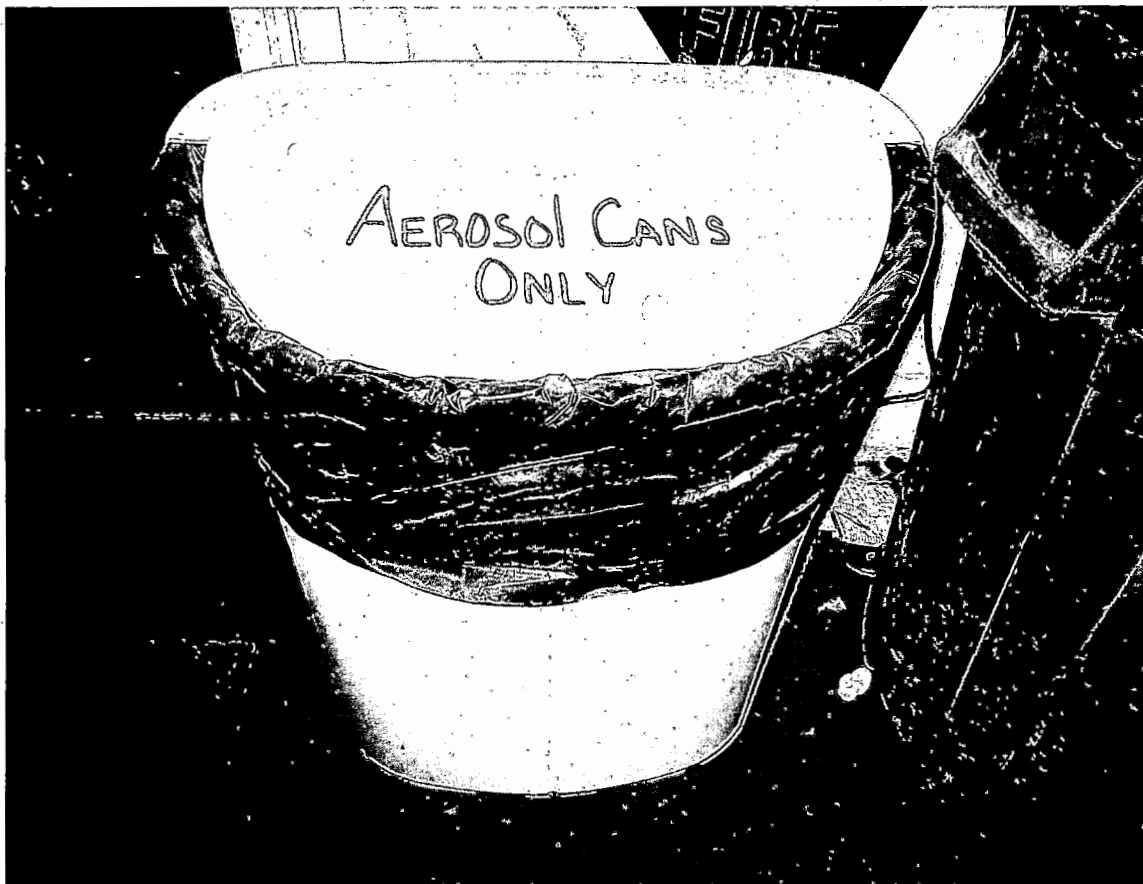
Photograph #1

At the time of the assessment, SHWMB representatives observed that as a result of the previous compliance assessments, the facility had put into service a container for the collection of empty aerosol cans. This container was labeled "Aerosol Cans Only" and was located in the front shop (Photograph 1). No violations were observed in this area.

✓ As a result of the December 13, 2007 and February 5, 2008 compliance assessment and follow-up compliance assessment, respectively, conducted by EPA Region III, Procino Plating put into service a container for the collection of empty aerosol cans.

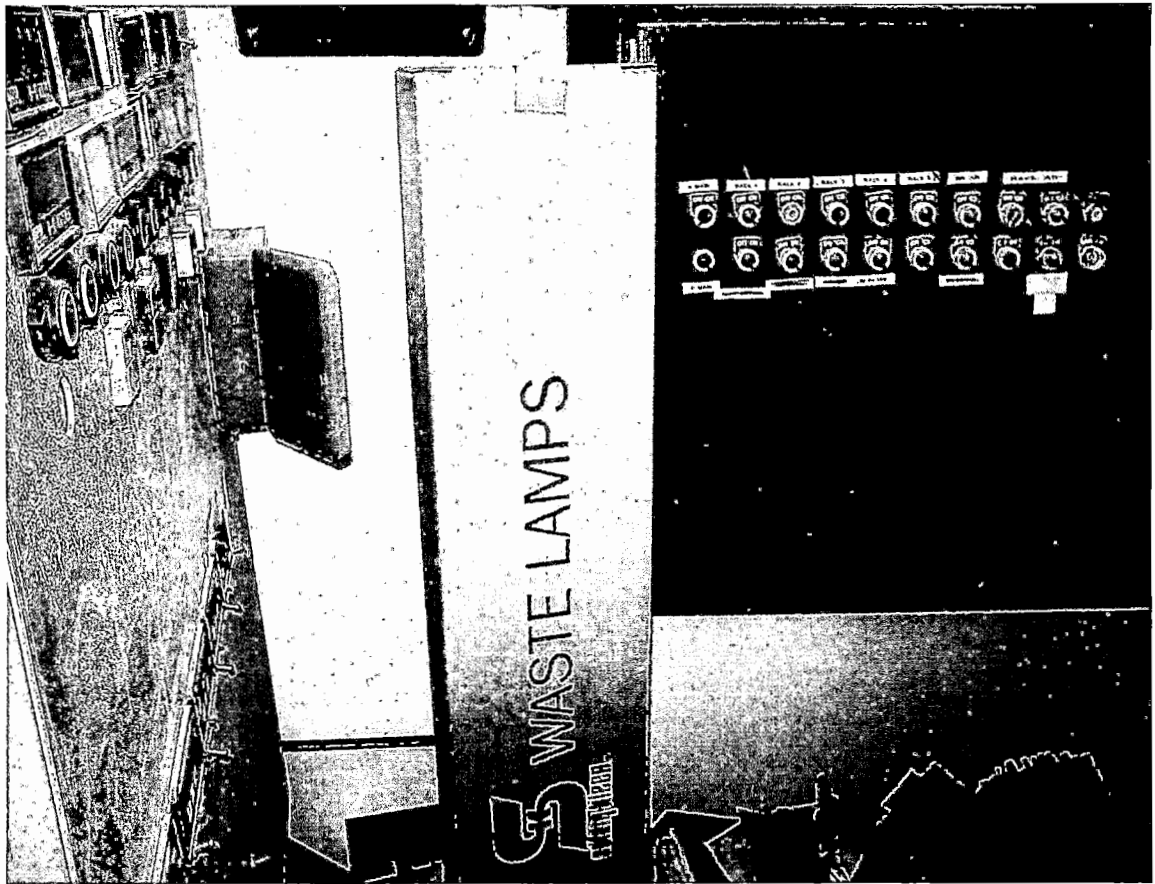
Photograph #2

At the time of the assessment, SHWMB representatives observed that as a result of the previous compliance assessments, the facility had put into service two (one 4-ft. and one 8-ft.) fiber containers for the accumulation of spent fluorescent lamps. These containers were labeled with the words "Waste Lamps" and were closed. Procino Plating has contracted with Safety Kleen to dispose of the spent fluorescent lamps when needed (Photograph 2). No violations were observed in this area.

As a result of the December 13, 2007 and February 5, 2008 compliance assessment and follow-up compliance assessment, respectively, conducted by EPA Region III, Procino Plating put into service a container for the collection of spent fluorescent lamps.

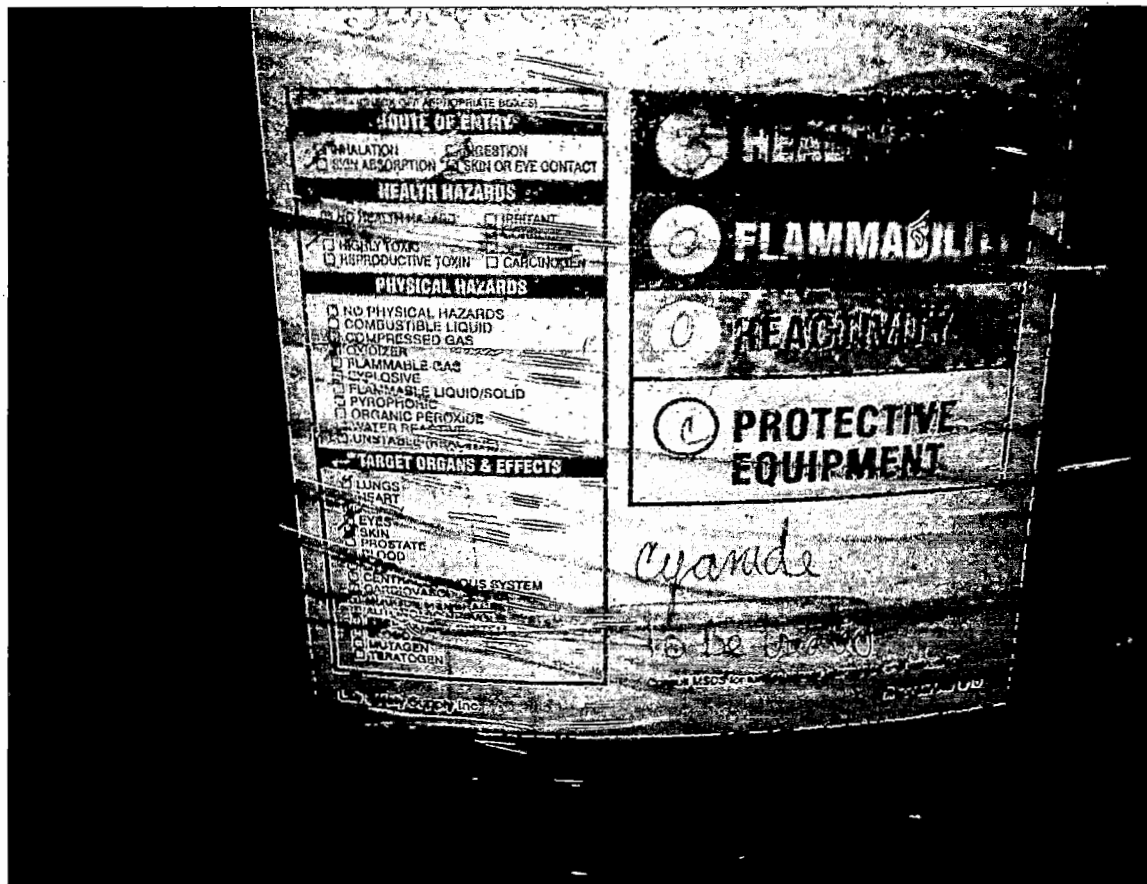
Photograph #6

SHWMB representatives observed four – 55 gallon drums containing brass cyanide plating bath solution. Mr. Procino stated in previous compliance assessments that this material was removed from the brass plating bath tank. Spent cyanide plating bath solutions from electroplating operations are considered a listed hazardous waste carrying the waste code F007. One drum was labeled "cyanide to be treated." Another was labeled "No good – to be treated." None of these containers were labeled with the words "Hazardous Waste" or marked with an accumulation start date (Photographs 5, 6, and 7).

This is a violation of Delaware's *Regulations Governing Hazardous Waste* §262.34(a)(3), which states:

This is also a violation of Delaware's *Regulations Governing Hazardous Waste* §262.34(a)(2), which states:

SHWMB representatives observed four – 55 gallon drums containing brass plating solution in the aisle to the right. This drum was labeled “cyanide to be treated.” Another was labeled “No good – to be treated.” None of these containers were labeled with the words “Hazardous Waste” or marked with an accumulation start date.

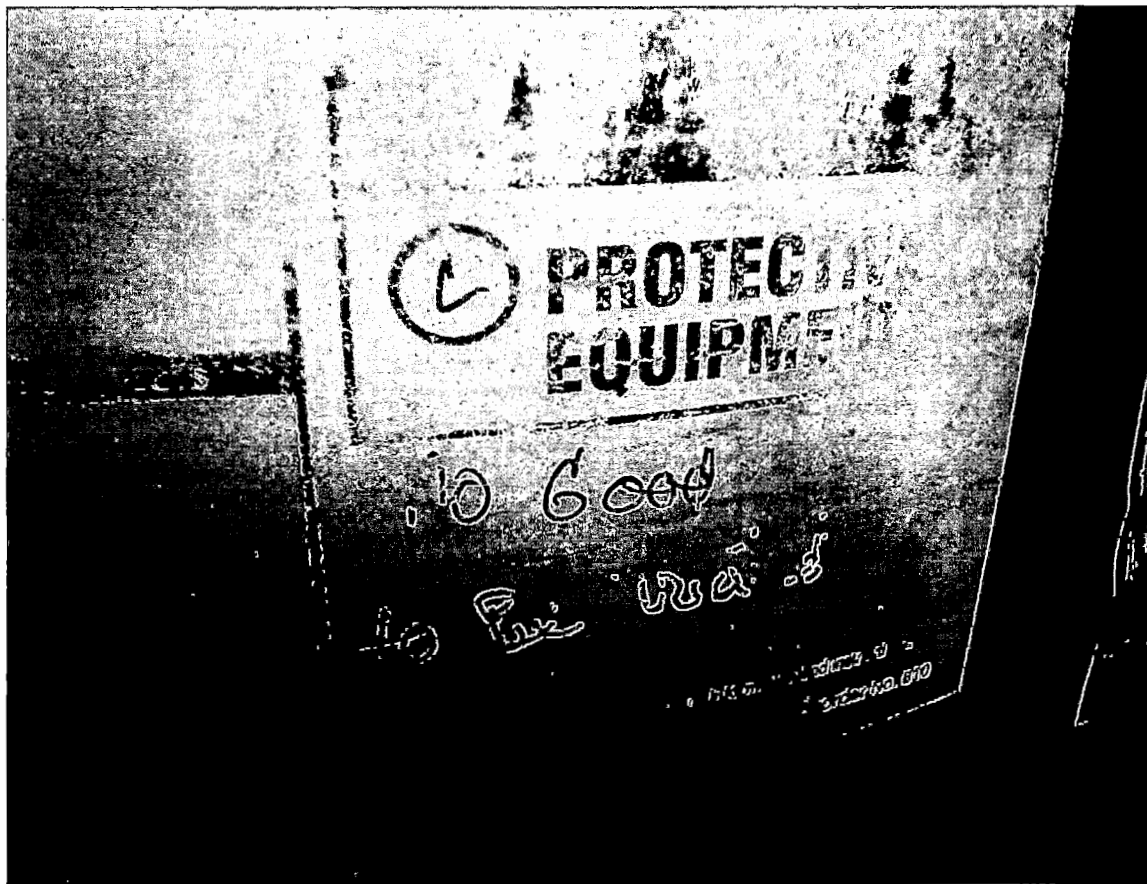
Photograph #7

SHWMB representatives observed four – 55 gallon drums containing brass plating solution in the aisle to the right. One drum was labeled “cyanide to be treated.” This drum was labeled “No good – to be treated.” None of these containers were labeled with the words “Hazardous Waste” or marked with an accumulation start date.

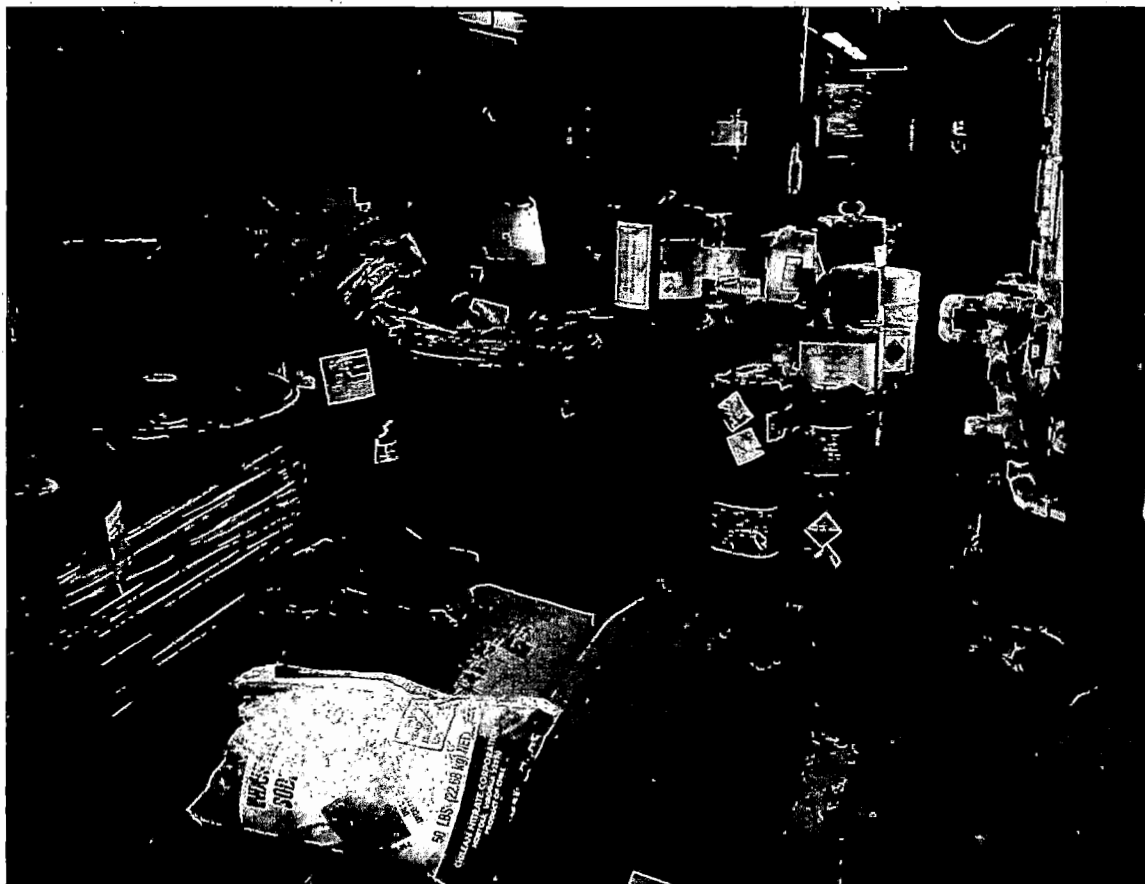
Photograph #8

The multiple containers documented in each previous inspection report were still being accumulated on-site. Previously, Mr. Procino had said these containers needed to be "gone through" to determine if the material was usable product or a waste. It was unclear at the time of the assessment if this had been done. In addition, the facility had moved everything from the small chemical store room in the back of the building to the area across from the WWT system (Photographs 8, 9, and 10).

SHWMB representatives observed multiple containers that had been present during the December 13, 2007 and February 5, 2008 compliance assessment and follow-up compliance assessment conducted by EPA Region III. Previously, Mr. Procino stated that these containers needed to be "gone through" to determine if the material was a usable product or waste.

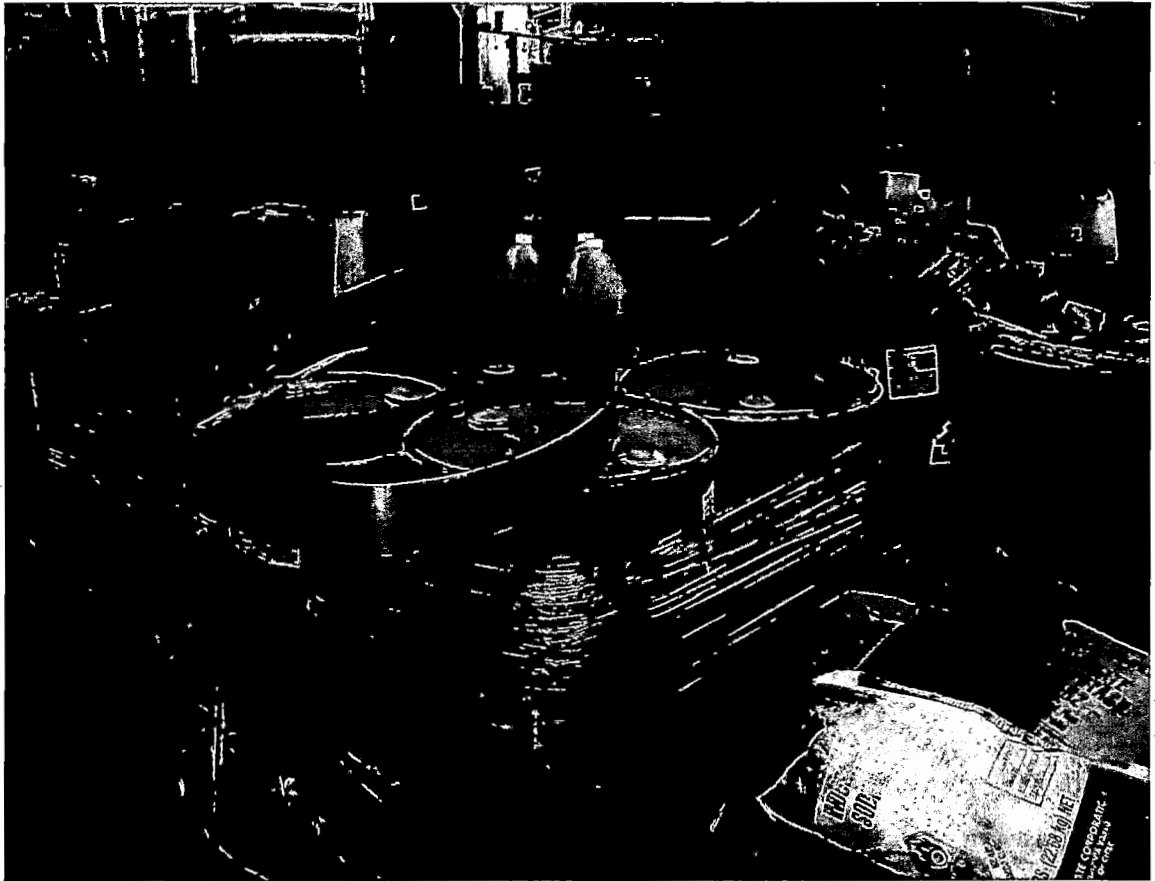
Photograph #9

SHWMB representatives observed multiple containers that had been present during the December 13, 2007 and February 5, 2008 compliance assessment and follow-up compliance assessment conducted by EPA Region III. Previously, Mr. Procino stated that these containers needed to be “gone through” to determine if the material was a usable product or waste. The four – 55 gallon drums in the forefront of this photograph contained tin plating baths, which Mrs. Procino stated they didn’t want to dispose of in case they could still be used.

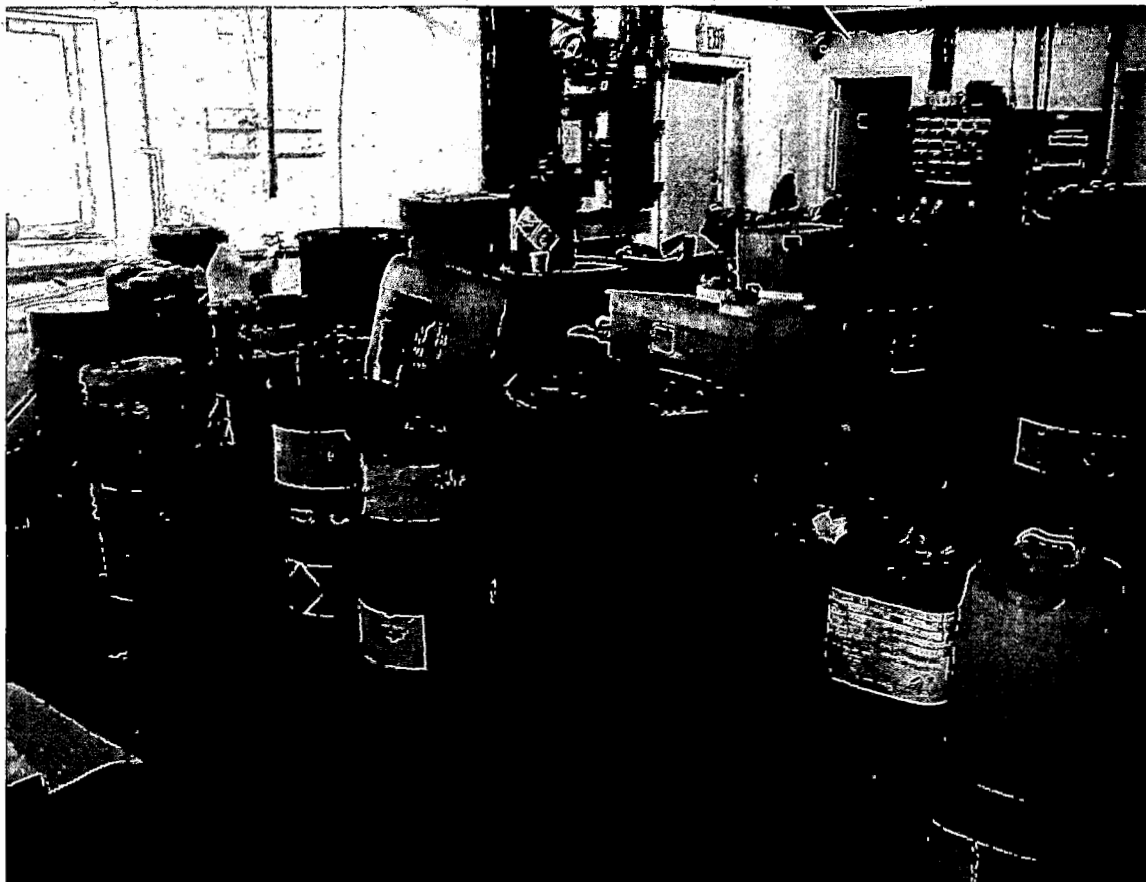
Photograph #10

SHWMB representatives observed multiple containers that had been present during the December 13, 2007 and February 5, 2008 compliance assessment and follow-up compliance assessment conducted by EPA Region III. Previously, Mr. Procino stated that these containers needed to be "gone through" to determine if the material was a usable product or waste.

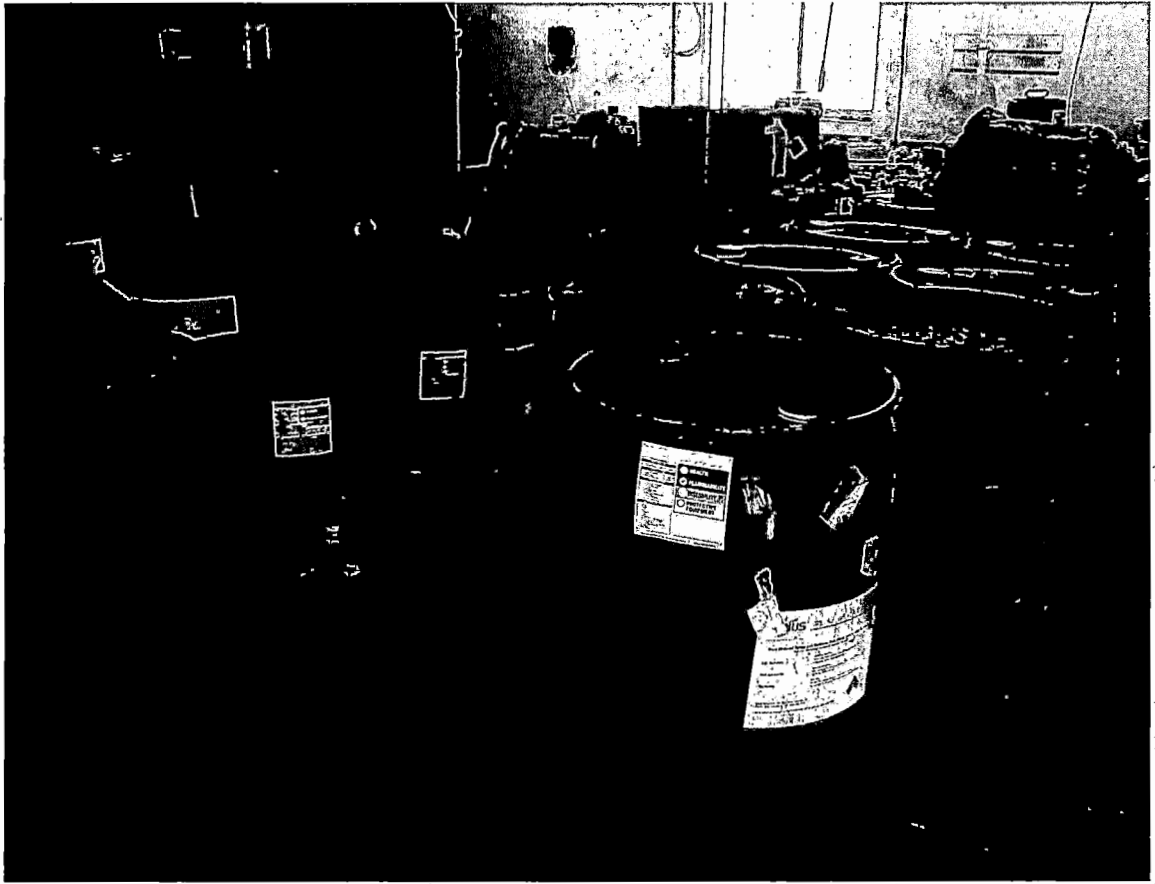
Photograph #11

SHWMB representatives observed four newly generated drums of hydrochloric acid and water that facility representatives stated had become waste the previous week. Mr. Procino stated during the February 5, 2008 follow-up compliance assessment that this waste stream had a pH of approximately 1. Because the pH of this waste stream is below 2, it is considered a characteristic hazardous waste carrying the waste code D002 (as defined in DRGHW §261.22). At the time of the assessment, these drums were not labeled with the words "Hazardous Waste" or marked with an accumulation start date on the container (Photograph 11).

This is a violation of Delaware's *Regulations Governing Hazardous Waste* (DRGHW) §262.34(a)(3), which states:

This is also a violation of DRGHW §262.34(a)(2), which states:

Also, with regard to the four newly generated drums of hydrochloric acid and water, and the three poly drums of solidified gold plating solution containing cyanide awaiting precious metals recovery shown in photographs 11, 12 and 13, note the proximity of these containers of incompatible wastes. Also, there is no dike, berm or wall between the drums.

The drums of waste are subject to the requirements of DRGHW Part 265, Subpart I. As stored, these drums violate §265.177(c) of Subpart I which states:

SHWMB representatives observed four new 55 gallon drums of hydrochloric acid and waster (pH~1) that facility representatives stated had become waste the previous week. At the time of the assessment, these drums were not labeled with the words "Hazardous Waste" or marked with an accumulation start date.

SHWMB and EPA representatives had discussed the need to immediately properly label containers of waste hydrochloric acid and water during the February 5, 2008 compliance assessment. SHWMB representative Melissa Ferree spoke to Mr. Procino on the telephone on July 7, 2008. During this telephone conversation, Mr. Procino stated that he knew the wrong labels were placed on the drums and acknowledged that the drums should have be labeled with words "Hazardous Waste" and marked with an accumulation start date.

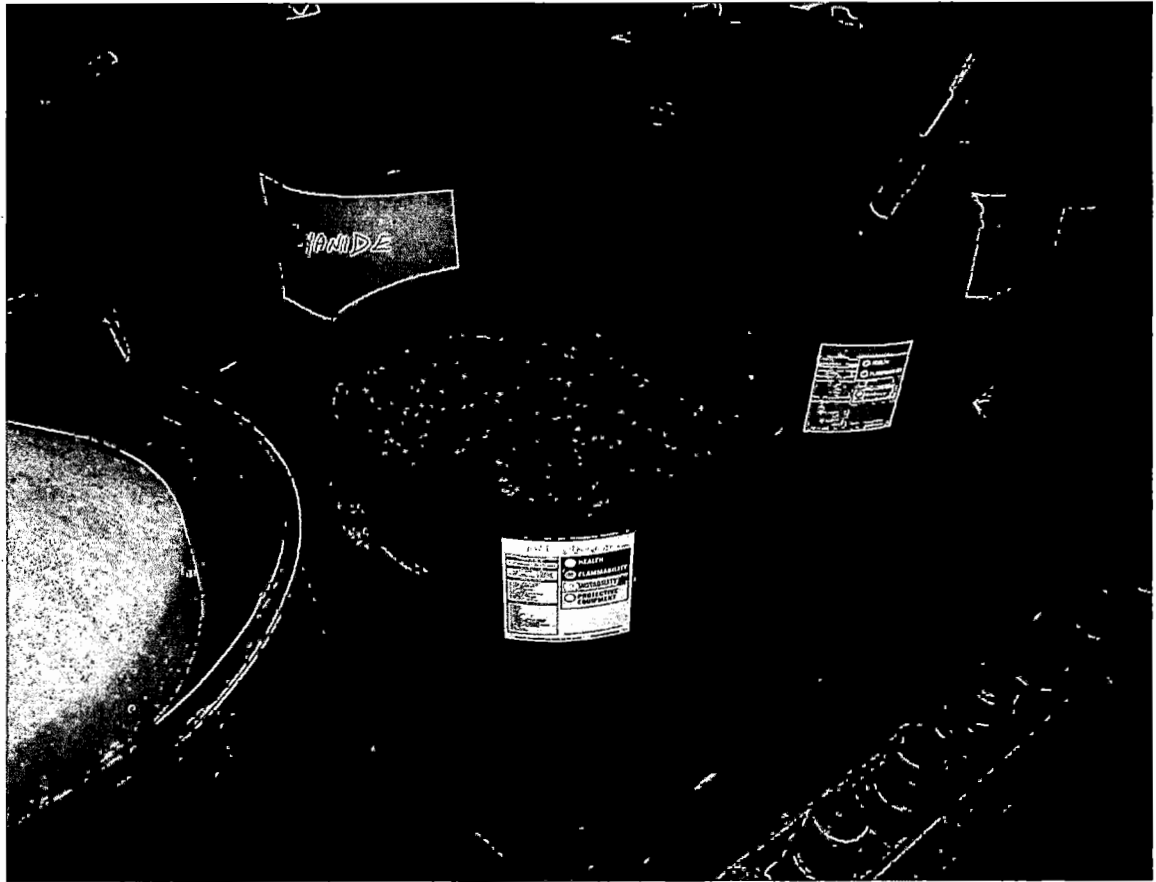
Photograph #12

SHWMB representatives also observed 3 poly drums with the top cut off used to accumulate gold plating solution (one of which contained cyanide). A solid similar to kitty litter is added to solidify the material at some point before it is sent off-site for gold reclamation. One of these containers was labeled with the word "Cyanide" and the other two were labeled "Gold Reclamation" (Photographs 12, 13, and 14). Facility representatives stated that this material is shipped off-site to a recycler without a hazardous waste manifest. This is a violation of DRGHW §266.70(b), which states:

In addition, under the "Precious Metal Exemption" in §266.70, the facility must maintain records demonstrating the materials are not speculatively accumulated. The facility is unable to provide this documentation. This is a violation of DRGHW §266.70(c), which states:

Too, as a large quantity generator of hazardous waste, Procino Plating is subject to the requirements of DRGHW § 265.31 titled "Maintenance and operation of facility." The storage of waste awaiting precious metals recovery is in open top drums, each having two open handles in the drum sides. This, as well as the proximity of acid waste in relation to the drums awaiting precious metals recovery violates the requirements of DRGHW §265.31 which states:

SHWMB representatives observed 3 poly drums with the top cut off used to accumulate gold plating solution (containing cyanide). A solid similar to kitty litter is added to solidify the material at some point before it is sent off-site for gold reclamation. One of these containers was labeled with the word "Cyanide" and the other two were labeled "Gold Reclamation." Facility representatives stated that this material is shipped off-site to recycler without a hazardous waste manifest.

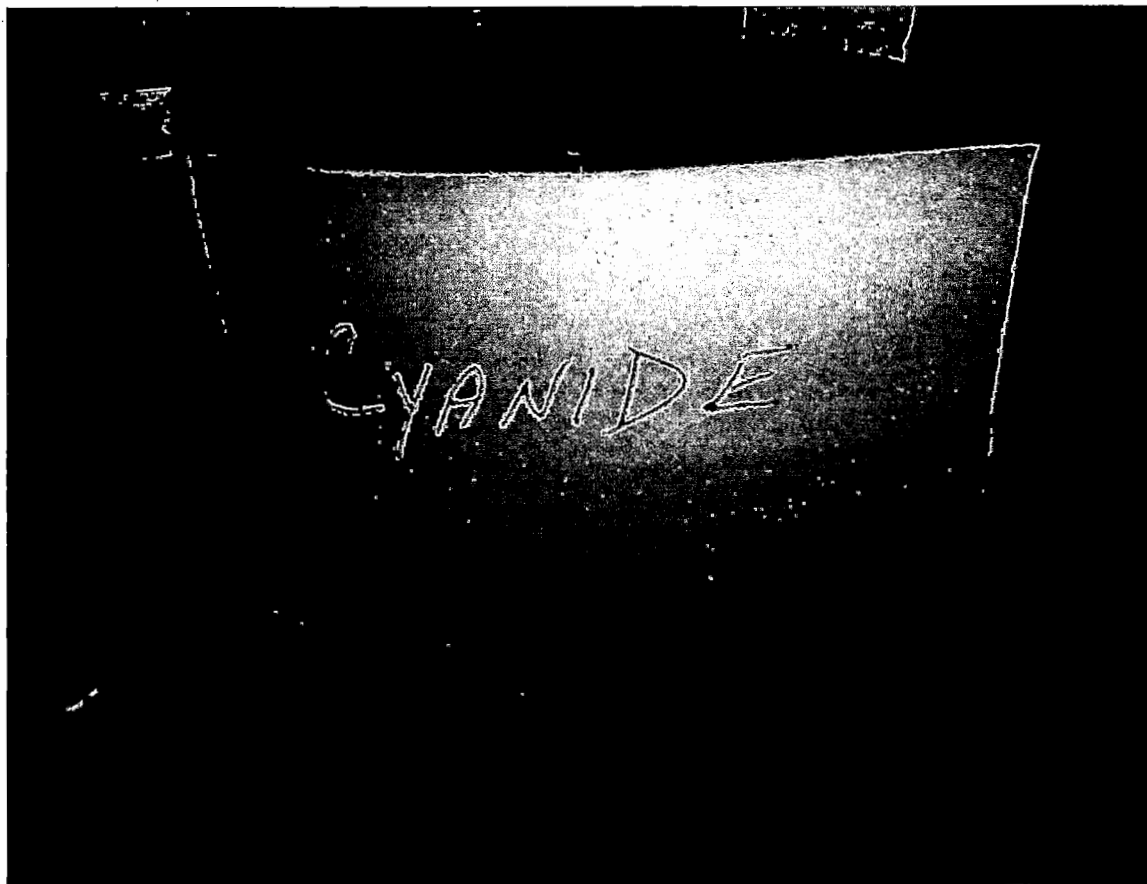
Photograph #13

SHWMB representatives observed 3 poly drums with the top cut off used to accumulate gold plating solution (containing cyanide). A solid similar to kitty litter is added to solidify the material at some point before it is sent off-site for gold reclamation. One of these containers was labeled with the word "Cyanide" and the other two were labeled "Gold Reclamation." Facility representatives stated that this material is shipped off-site to recycler without a hazardous waste manifest.
